FRACTOGRAPHIC INVESTIGATION OF FAILURE IN STAINLESS STEEL ORTHOPEDIC PLATES

Dušan Petković^{1#}, Goran Radenković¹, Milorad Mitković²

¹Faculty of Mechanical Engineering, University of Niš

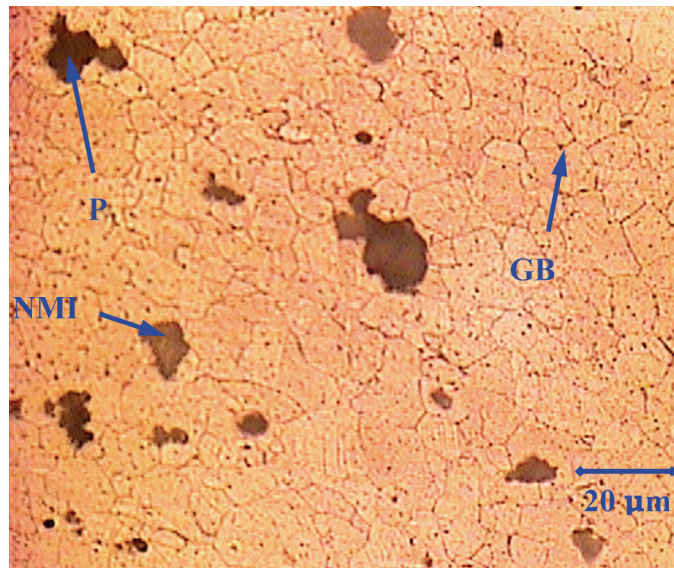
Representative optical micrograph for tested steel is shown in Fig. 2. It can be seen that their microstructure comprises a single phase matrix consisting of average grains size of austenite with a certain number of non-metallic inclusions (NMI) and pores (P).

Fig. 2 Optical micrograph of transverse section of plate 3, GB – grain boundary, NMI – non-metallic inclusion, P - pore

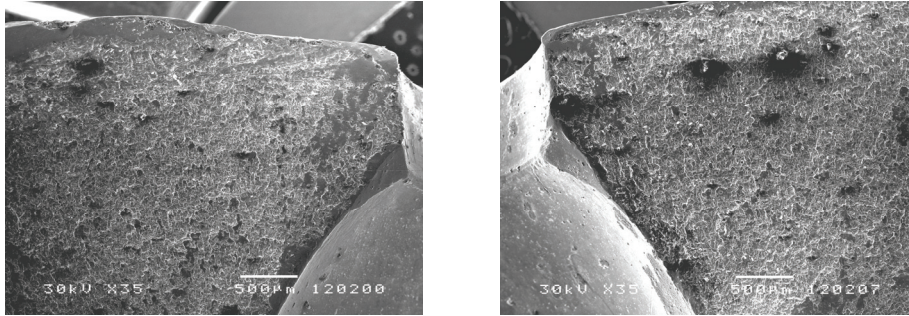
Visual examinations of the fracture surfaces of the plates suggest the complete absence of corrosion contribution to the failure process (see Figs. 3-5). The presence of narrow flat areas along the ledge can be seen in the given Figs. The narrow area can be seen clearly in Fig. 4 but it is noticed for all other samples. The presence of narrow zones along the edge of plates with relatively smooth surface points to fatigue initiation in all the six plates. The crack origin is not possible to determine exactly in these cases because

The rest of the fracture surface consists of the relief surface indicating to static mostly brittle fracture, caused by a relatively high stress. Moreover, this surface contents damages due to metallurgical defects (non-metallic inclusions, pores, etc., Figs. 3, 4) and damage due to mechanical actions of mating fractured parts (see Fig. 5).

Fig. 3 SEM macrograph of fracture surface plate 1

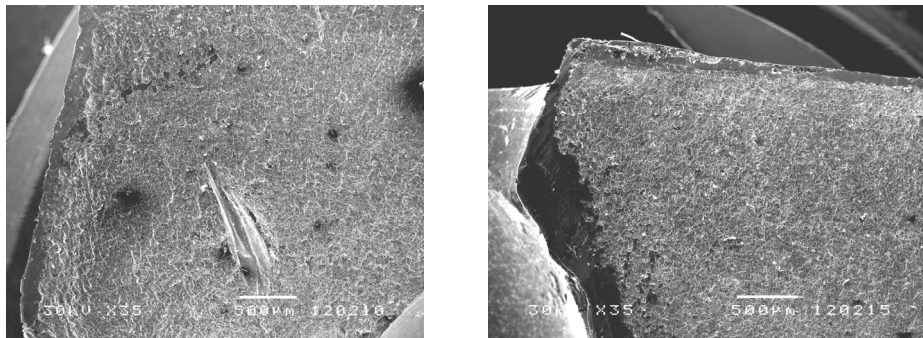
Fig. 4 SEM macrograph of fracture surface plate 2

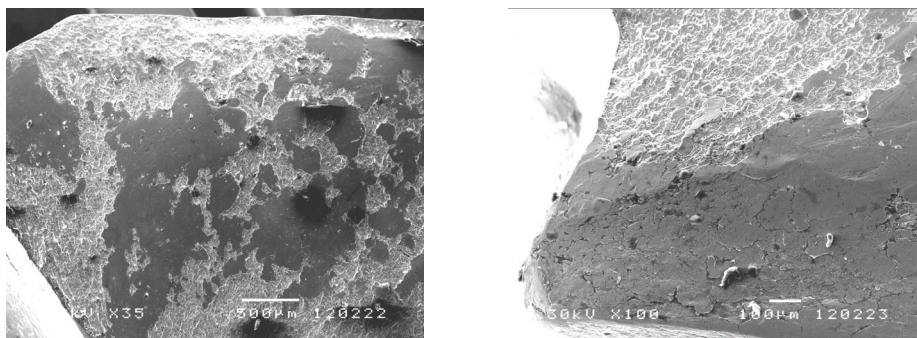
Fig. 5 SEM macrograph of fracture surface plate 5

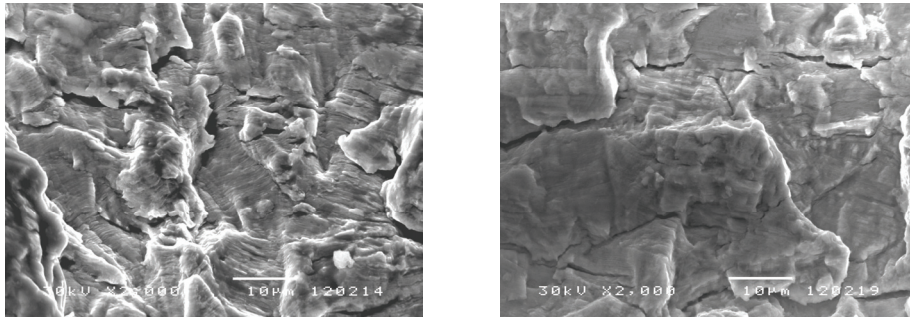
Fast fracture region of one plate is uniform considering type of fracture. A slight difference between types of static fracture can be seen for all the plates. There is a mostly brittle fracture (see Fig. 6) and brittle with element of ductile fracture (see Fig. 7).

Fig. 6 SEM micrograph of fast fatigue region of plate 2

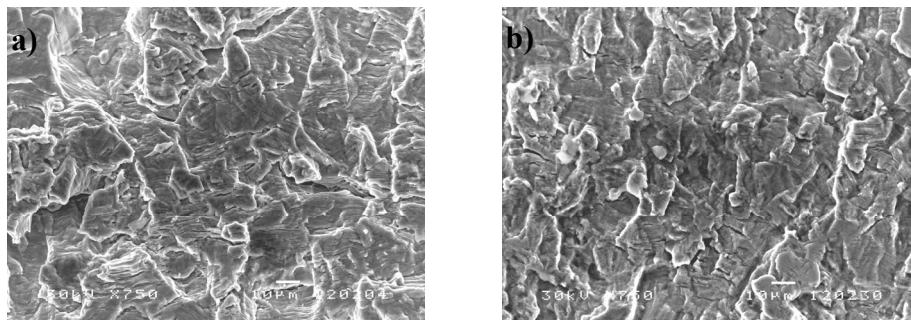
Fig. 7 SEM micrograph of fast fatigue region of: a) plate 1 and b) plate 5
