UNIVERSITY OF NIŠ The scientific journal FACTA UNIVERSITATIS Series: Mechanics, Automatic Control and Robotics Vol.2, No 9, 1999 pp. 895 - 901 Editor of series: Katica (Stevanovi)) Hedrih, e-mail: katica@masfak.masfak.mi.ac.yu Address: Univerzitetski trg 2, 18000 Niš, YU, Tel: +381 18 547-095, Fax: +381 18 547-950 http:// ni.ac.yu/Facta

CRACK GROWTH RESISTANCE OF CREEP DAMAGED MATERIAL

Biljana Grujić¹, Stojan Sedmak², Zijah Burzić³, Aleksandar Sedmak⁴

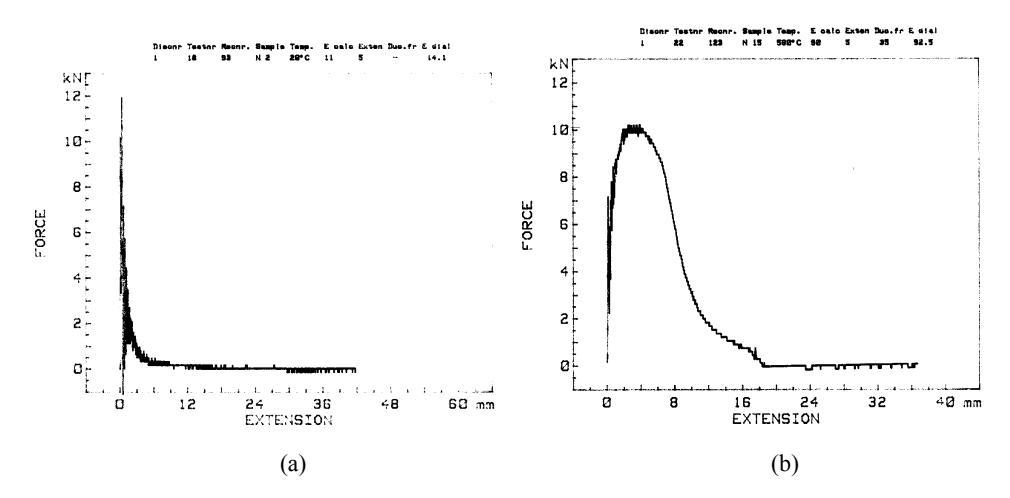
Fig. 4. The force-displacement curves for damaged material (a) 20°C; (b) 560°C

The most important result for the exposed material testing is certainly extremely low value of total impact energy at 20°C. All three specimens fractured in the same, brittle manner, producing "A" type of force-displacement diagram [1, 2], which can not be used to separate crack initiation and growth energy (the latter one is practically zero). It is obvious that the transitional temperature has increased above room temperature, indicating significant change in the creep damaged material behavior at impact load.

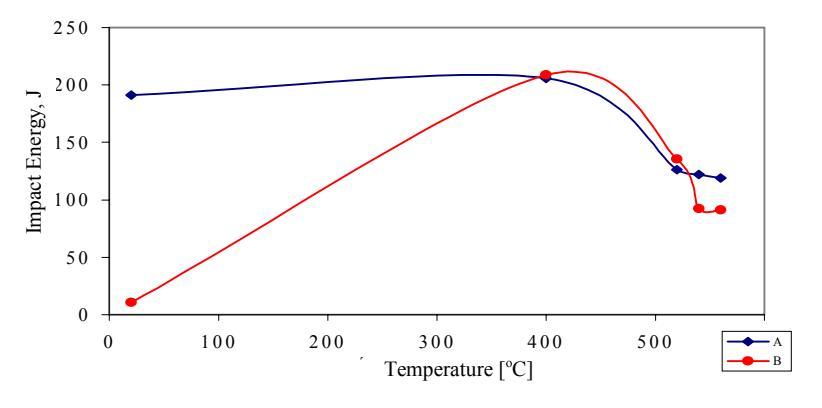
Comparison of total impact energies for virgin and exposed materials is given in Fig. 5. As already explained, significant change in material behavior occurs at 20°C, whereas differences at higher temperature are much smaller, but more expressed for higher temperatures than for the intermediate ones. In the latter case the total impact energy is actually higher for the exposed material.

Fig. 5. Comparison of total impact energies for virgin (A) and exposed (B) materials

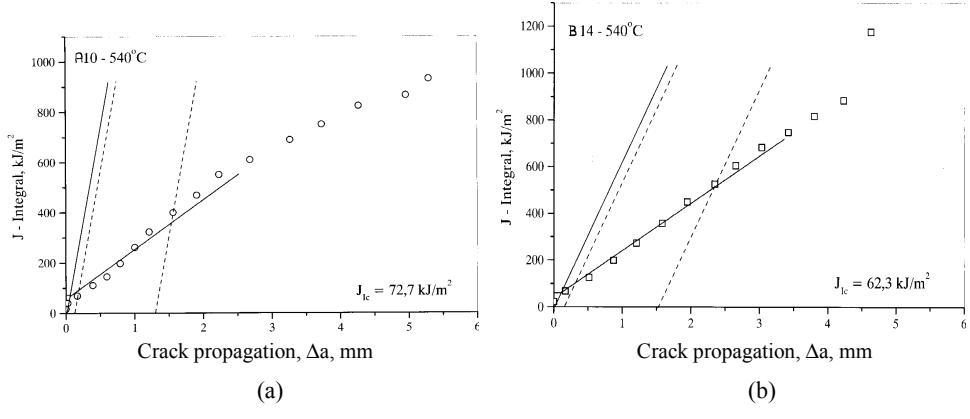
Fig. 6. Evaluation of J_{Ic} values from J-R curves at 540°C (a) virgin material (A); (b) damaged material (B)

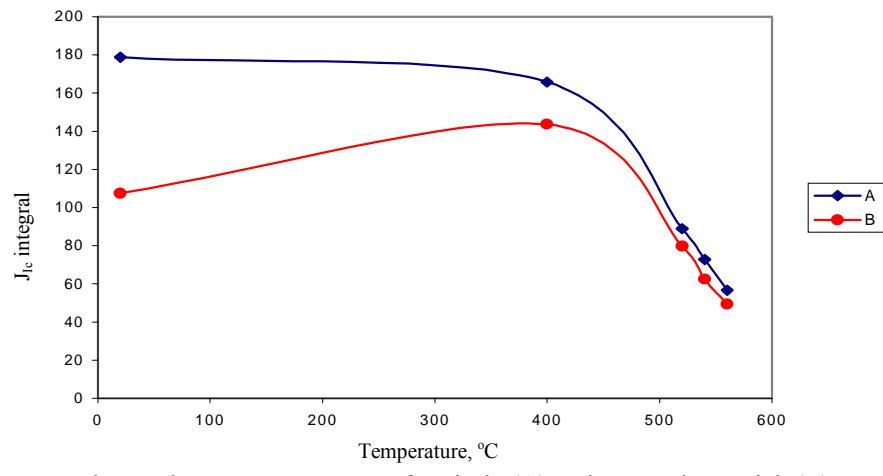
Fig. 7. The J_{Ic} vs. temperature for virgin (A) and exposed material (B)

From Fig. 7 it is evident that both materials behave similarly as in the case of Charpy testing, but with one exceptional difference: fracture toughness reduction at room temperature for exposed material is not nearly that drastic as it was the case with impact toughness.

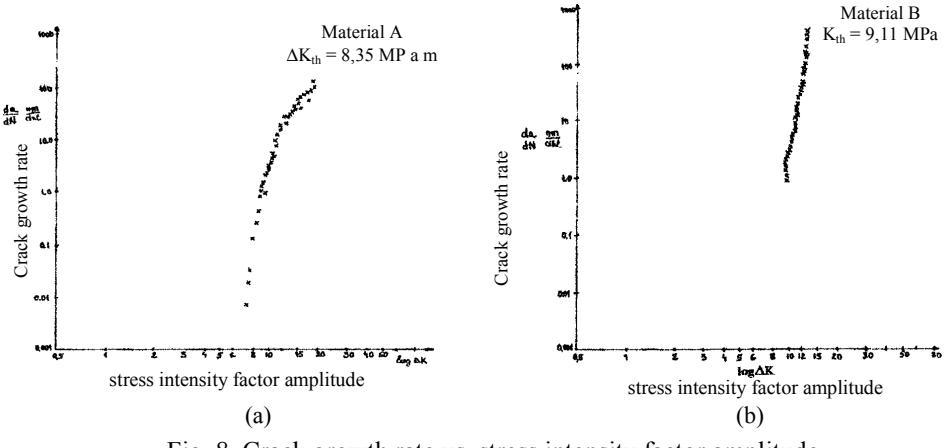
The high cycle fatigue testing was performed on pre-cracked Charpy specimens using AMSLER FRACTOMAT machine. The crack growth rate was registered by strain gages RMF- A5. The results are shown in Fig. 8a and 8b for the virgin and damaged material, respectively, in form of crack growth rate (da/dN) dependence on the stress intensity factor amplitude (ΔK). These results indicate an order of magnitude higher crack growth rate for the damaged material, but almost the same threshold values for the stress intensity factor amplitude (ΔK_{th}).

Fig. 8. Crack growth rate vs. stress intensity factor amplitude (a) virgin material (A); (b) damaged material (B)

- -Fatigue testing resulted in significant increase of crack growth rate for the damaged material, indicating high susceptibility of this material to fatigue crack growth under creep conditions. Anyhow, since the threshold values for stress intensity factor amplitude are almost the same, one can conclude that crack initiation phase in fatigue process is not affected in the same way.
