## **APPLICATION OF THE URBAN RECONSTRUCTION METHODS IN THE CENTRAL CITY AREA OF NIŠ**

**Milena Dinić, Petar Mitković, Jelena Velev, Ivana Bogdanović**

University of Niš, Faculty of Civil Engineering and Architecture, Serbia

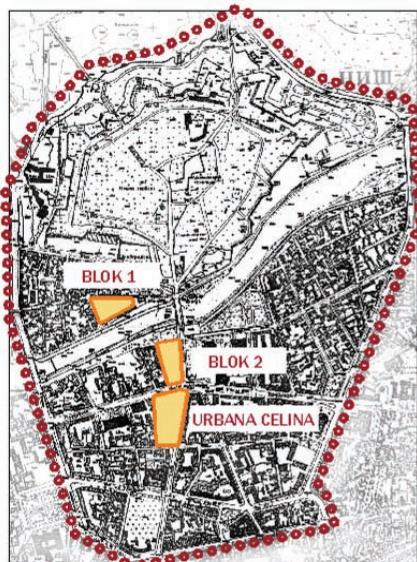
- BLOCK 1: Edifice of the old District Government, and now the seat of the University of Niš, protected as a *cultural monument of extreme importance*;
- BLOCK 2: group of old building on the west side of the King Milan Square, protected as *cultural monuments*;
- URBAN UNIT: segment of the pedestrian and commercial Victory street, protected as the *cultural-historical unit*, from the King Milan Square to the Svetozar Markovic street.

Fig. 1. Analysed areas in the central city area of Niš.  
Source: authors

In the central city area of Niš, in the last thirty years, multiple interventions were carried out, in terms of urban reconstruction of the city. This paper has chosen three areas of various spatial, architectonic and urban characteristics for the needs of the analysis of the applied methods of urban reconstruction in this time period (figure 1):

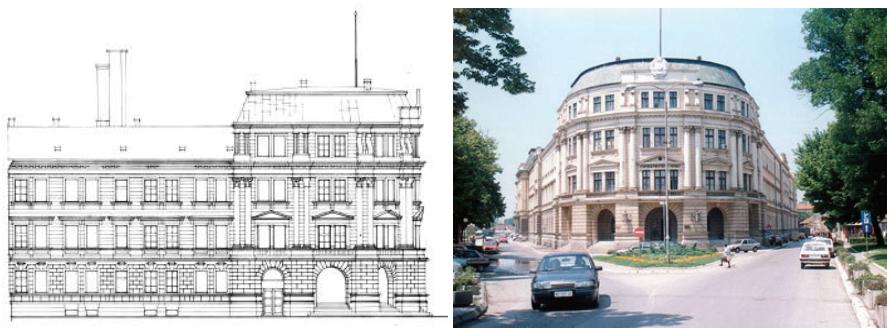
Figs. 2, 3. Remedial works and restoration of the University building 1977 – view from the Mika Paligorić Quay (left) and present day appearance (right). Sources: documentation of The Cultural Monuments Protection Institute of Niš, and <http://www.nis.co.yu>

The reconstruction of the University building was conducted in 1976 – 1977 interval according to the design of the Cultural Monuments Protection Institute of Niš. As it is a cultural monument of extreme importance, the design required to absolutely preserve the authentic appearance of the structure (figures 2, 3). Urban reconstruction of this block was carried out in three phases: first the oldest, south-west part of the structure, then the northern part, and in eventually the east side part of the building. On the basis of the executed interventions, it can be concluded that the applied methods were the restoration and remedial works. As to the future procedures on this valuable monumental structure, a transitional group of urban reconstruction methods is recommended.

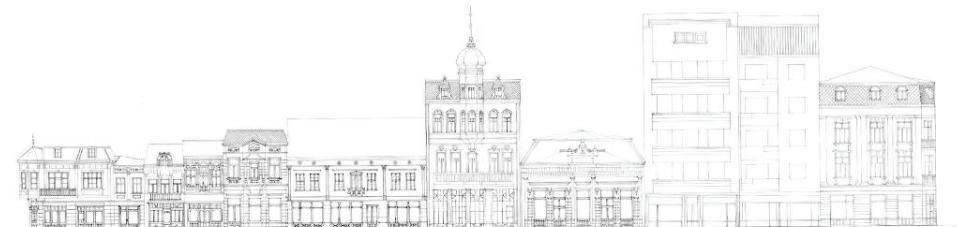
Fig. 4. Appearance of the revitalized structures in BLOCK 2.  
Source: The Cultural Monuments Protection Institute of Niš.

Adapting to the needs and the city development, the structure of the block changed the content and purpose in time. The first serious interventions of the urban reconstruction of the area were carried out in the 80s of the 20<sup>th</sup> century, and the applied method was revitalization. The realization of the project successfully renovated this row of valuable old structures of the city nucleus, preserving the spirit of the place at the same time. In the revitalization procedure, the restoration, change of function and adaptation methods were applied (figure 4).

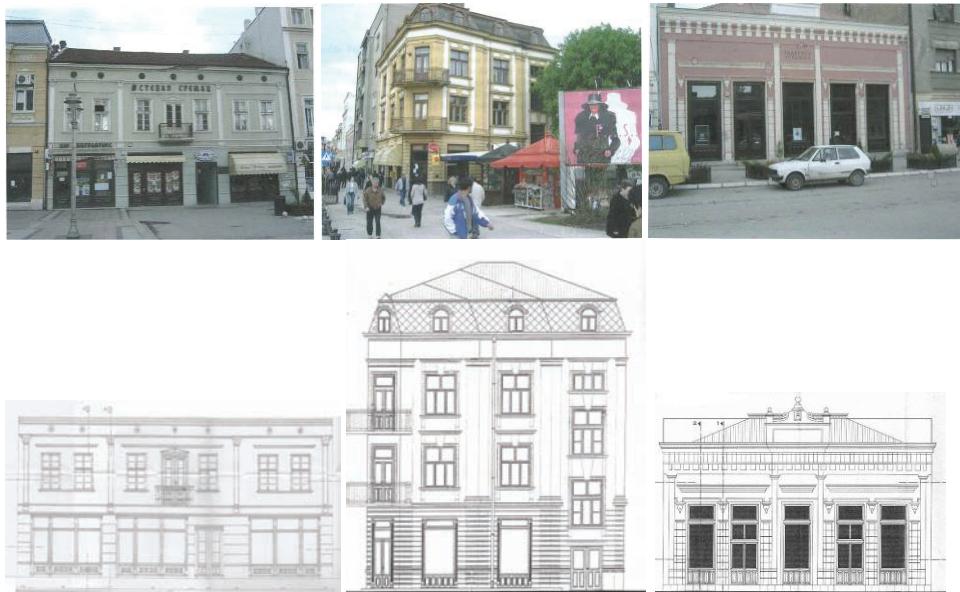
Figs. 5-10. Buildings "Stevan Sremac", "Svetlost" and "Srbija" prior to remedial and restoration works (up) and appearance planned by the project (down).

For the structures of the Modern Visual Arts Gallery, "Svetlost" book-shop and "Stevan Sremac" book-shop, the remedial and restoration works of the facades were chosen as the reconstruction methods. (figures 5-10). The technical protection measures of these structures proscribed by the Institute, comprised the following:

The book-shop "Stevan Sremac" building is the oldest preserved structure, built around 1890. The east façade is its most valuable part, owing to the successful composition with good proportion, and historical value. The restoration and remedial works project of this quite ruinous façade, instructed the complete smooth coating and painting with the façade color, in a tone specified by the designer. The worn-out elements of roof structure and roof covering of grooved roof-tiles were replaced by crown tiles. The worn-out elements of façade plastics were reconstructed according to the authentic detailed. The ruinous façade joinery elements were repaired and the complete flashing is replaced.

The "Svetlost" book-shop was built in 1927. The successful vertical composition, consisting of a ground floor, two floors and a mansard, this building represent a recognizable corner landmark with a rich façade plastics. The restoration of the worn out faced meant smooth coating and painting as finish, and all the elements of rendering were done according to the original samples. The worn out covering of the mansard of eternit is completely replaced with the same material and the interlocking tile replaced with crown tiles. A part of the damaged façade joinery and the flashing underwent remedial works.

The building of the Modern Visual Arts Gallery was erected in the last decade of 19<sup>th</sup> century. Great height of the ground floor, symmetrical composition and the decorative plastics and hipped roof with the decorative cornice provide a monumental appearance to the structure. The status of the object was characterized by the poor state of the façade

and roof cover, and the original hipped roof provided water drainage onto the adjacent structures. The restoration project inserted new double-pitched roof planes above the great hall, with the ridges normal to the adjacent structures on the north and south sides. This eliminated the non-functional eaves troughs between the structures of various heights, so the water drains towards the corner gutter pipes. The inappropriate roof cover of everite, which was a result of previous inadequate remedial works, is replaced with crown tiles and copper roofing. The complete façade surface is repaired and painted in the appropriate colors.

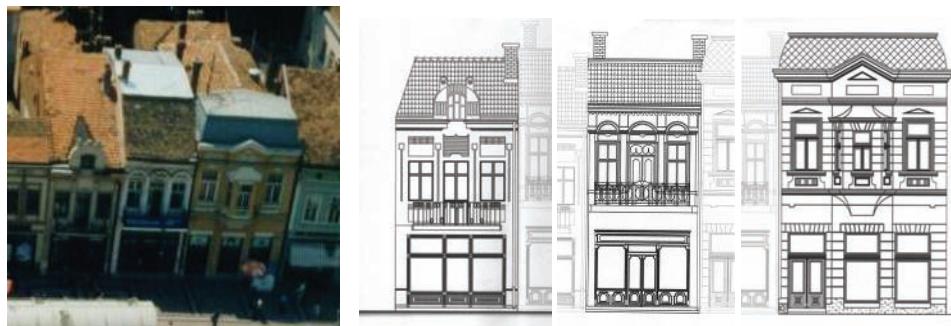
Figs. 11, 12. Structures on the King Milan Square nos. 3, 5, 7 prior to revitalization and adaptation (left) and appearance according to project (right).

For the following structures: sweet-shop "Pelivan", casino "Namitex", casino "Mezija" and two housing-business building nos. 15 and 19 at the King Milan Square the chosen reconstruction methods were adaptation and revitalization (figures 11-14). The conditions of technical protection of these structures prescribed by the Cultural Monuments Protection Institute of Niš, were the same as in the previous group of structures where remedial and restoration works were carried out. Since the adaptation of these buildings was permitted, the Institute prescribed an additional measure – that all the alterations of the existing status of structures in terms of their dimensions or functional usage can be undertaken only on the basis of a separate act issued by the competent Institute.

The group of structures on the King Milan Square nos. 3, 5 and 7 was built in 20s of the previous century. The revitalization of the housing-business structures nos. 3 and 5 comprised replacing the aged roof structure, replacing the roofing with crown tiles, painting of

east façade and joinery, and replacing the flashing with new copper sheets of the same shape and profile. The business building no 7 was in quite good condition. The interventions in realization were small and comprised painting of façade walls and joinery.

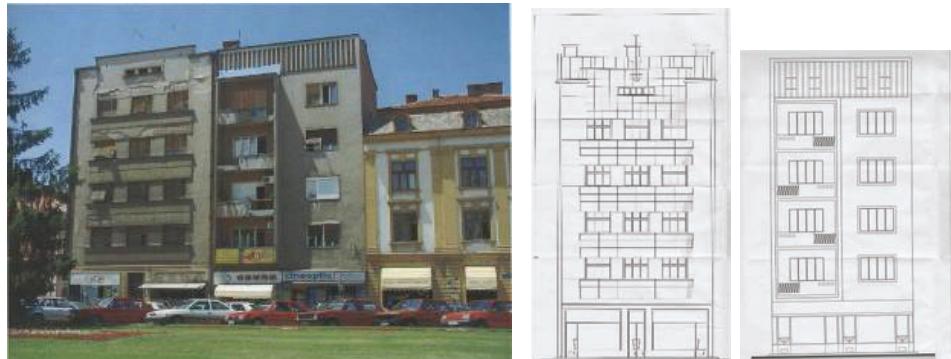
Figs. 13, 14. Structures on the King Milan Square No.15 and 19 prior to revitalization and adaptation (left) and appearance according to project (right).

The housing – business building on the King Milan Square no. 15 was built in 1940, and building no. 19 in 1957. IN the framework of revitalization of both structures, the worn out roofing, flashing and window shutters were replaced. The facades were rendered and painted. The joinery was also painted.

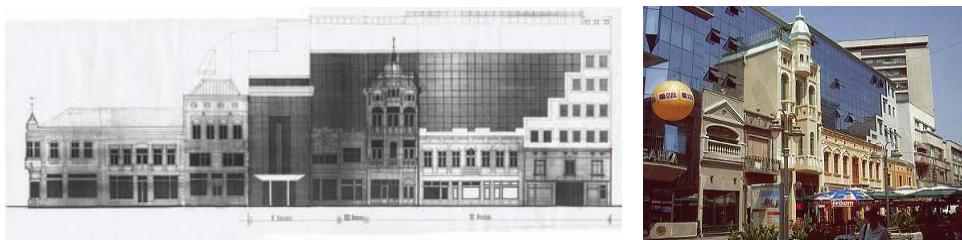
Figs. 15, 16. Reconstruction and revitalization of the part of the block B: west façade front of the Obrenoviceva street.

the construction of a new structure, providing that the authentic and original facades (according to the documentation) are preserved. The Cultural Monuments Protection Institute of Niš was a part of the project. The newly constructed structure "Gorča" occupies the location of the structures no. 12-26, as well as the part of the interior of B block (figures 15, 16).

The project of reconstruction and revitalization of the part of B block had three phases. On the basis of the present status, it can be concluded that during this complex procedure the numerous methods of urban reconstruction were applied: revitalization, restoration, change of function, reconstruction, adaptation and interpolation. The entire new structure of TPC "Gorča" was smoothly fit into the existing urban tissue by pulling slightly back the main modern façade in respect to the authentic façade front.

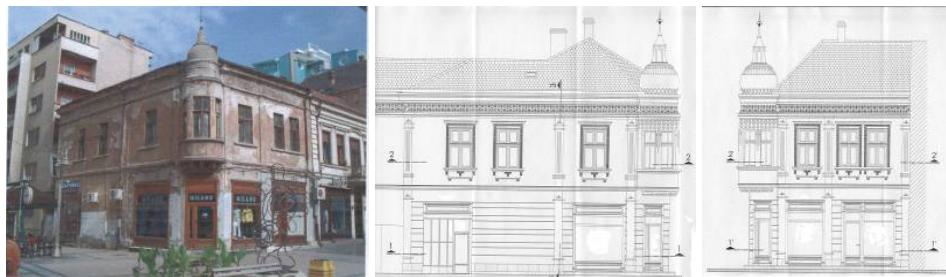
Figs. 17, 18, 19. The Jovanović palace prior to the remedial and restoration works in 2004.(left) and appearance according to the project (right).  
Source: documentation of the company "Door engineering" Niš.

Obrenovićeva and Svetozara Markovića street were carried out (figures 17, 18, 19). The restoration and remedial works were done on the basis and according to the conditions for technical protection by the Cultural Monuments Protection Institute of Niš.

The structure was in a very poor condition prior to reconstruction. Due to the ruinous façade and the entire secondary façade plastics, it was not possible to reproduce the original appearance of the structure. The project planned the remedial and reconstruction works according to the available documentation, so that the building receives its original appearance from the best period. The worn out roof structure and roofing were replaced, the façade surfaces with complete decoration were renovated, the old inadequate portals were replaced with the new ones, according to the original details, and the destroyed garden premises were reconstructed. The remedial and restoration works executed according to the authentic details, revived one of the most significant landmarks of the Obrenoviceva street.
