THERMAL BRIDGES IN BUILDINGS AS A RESULT OF URBAN TRANSFORMATION

Abstract. *The paper analyzes the deterioration of energy performance in buildings and construction defects caused by thermal bridges resulting from changes taking place in urban planning, for example in Vojvode Stepe street in Belgrade. The transformation of the urban matrix done over the last 50 years coupled with a time lag in implementation, resulting in partial sequences to completed buildings, has left a number of free side walls (gable ends), which are exposed to temperature influences. In some cases, these walls are adequately heat-treated, but in many others (especially in existing buildings) they are not, causing increased heat loss mould growth, leading to construction damage, and health risks to users.*

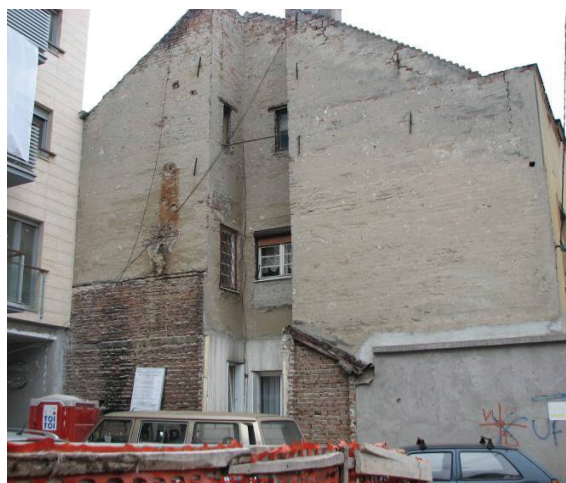
In the analyzed example, the old house from 1937 was left with bare gable walls, because the small adjacent pre-war houses were destroyed and in 2010 a residential building GF +7 was erected (Fig. 2).

During the long period of service, before this urban transformation, problems did not occur in the interior, although a wall made of solid brick, 25 cm thick, plastered outside with lime mortar, was largely damaged with the passage of time. The floor construction above ground floor is a full reinforced concrete slab, 12cm thick.

After demolition of the old adjacent house, the corresponding side wall is bare, the storey reinforced concrete slab is unprotected out on the facade, and an additional aggravating factor is the non-plastered facade area, with unfilled joints.

Fig. 2 Side (gable) wall of the old house

The only correct and durable construction intervention, in this case, is the application of external thermal insulation, with adequate protection of the facade, which actually causes new problems (stated above).

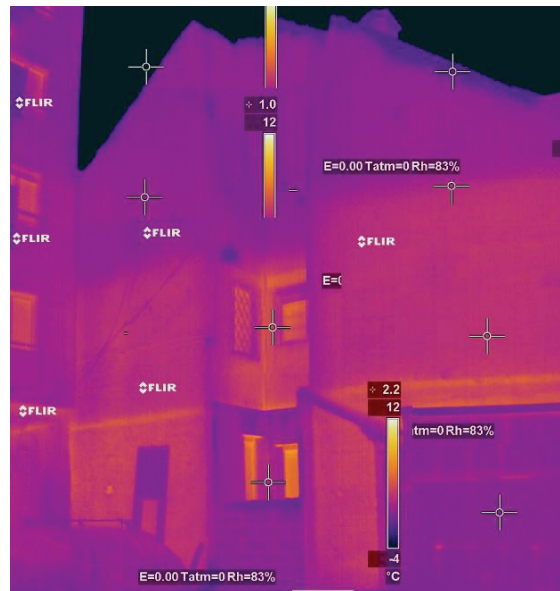
Increased heat losses are illustrated by thermal imaging (Fig. 3), where heat flow in the floor slab zone can be clearly seen.

Fig. 3 Thermovision image of side (gable) wall

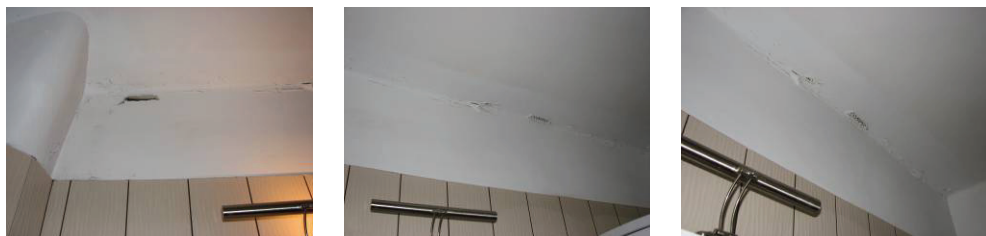
During the autumn and winter months, mould occurred in the bathroom, at the junctions of the wall and ceiling and the wall and window (not directly related to the considered connection).

This did not yield results, because after 10 days, the anti-fungicidal coating began to flake, and in these parts mould once again formed colonies (Fig. 4), clearly expressed as the result of additional heat flow caused by the thermal bridge (Fig. 5).

Fig. 4 Photo bathroom interior (junction: wall – ceiling)

Due to the impossibility of external intervention, repairs from the inside were accessed, the mould was removed, and anti-fungicidal coating was applied (Pherma white).
