UNIVERSITY OF NIŠ The scientific journal FACTA UNIVERSITATIS Series: Mechanics, Automatic Control and Robotics Vol.2, No 9, 1999 pp. 895 - 901 Editor of series: Katica (Stevanovi)) Hedrih, e-mail: katica@masfak.masfak.mi.ac.yu Address: Univerzitetski trg 2, 18000 Niš, YU, Tel: +381 18 547-095, Fax: +381 18 547-950 http:// ni.ac.yu/Facta

CRACK GROWTH RESISTANCE OF CREEP DAMAGED MATERIAL

Biljana Grujić¹, Stojan Sedmak², Zijah Burzić³, Aleksandar Sedmak⁴

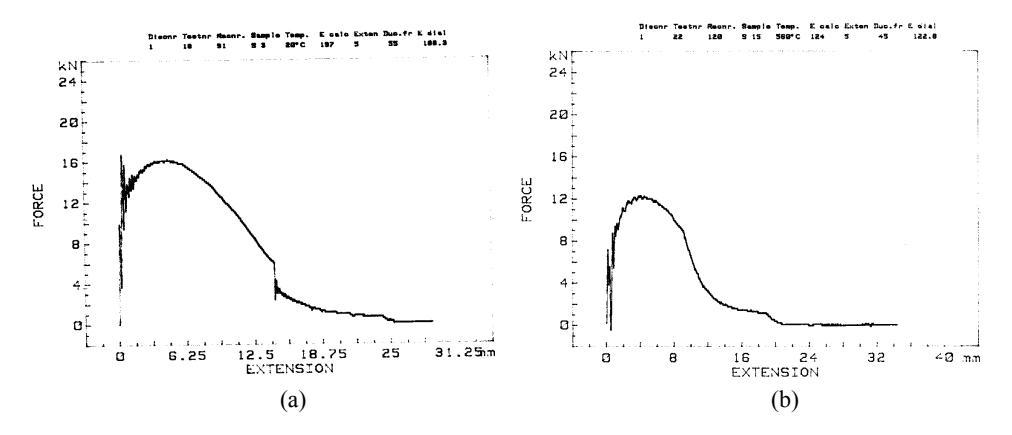
Fig. 3. The force-displacement curves for virgin material (a) 20°C; (b) 560°C

As one can see from results in Tab. 1, the total impact energy of virgin material increases slightly up to 400° C, and reduces significantly, but not drastically, above 400° C, so that its value is still more than sufficient at 560°C. Similar behavior is noticeable for crack initiation and growth energy, ductile fracture ratio, maximal force and dynamic yield force, with only differences at 400° C – while crack growth energy and ductile fracture ratio slightly rise, the other quantities lower their values to the level also recorded at other high temperatures.
